**Tiffin Hill, Carterton District**

**Geotechnical engineering  
assessment for proposed  
Schaef subdivision**

**November 2007**

**Project Number 963**

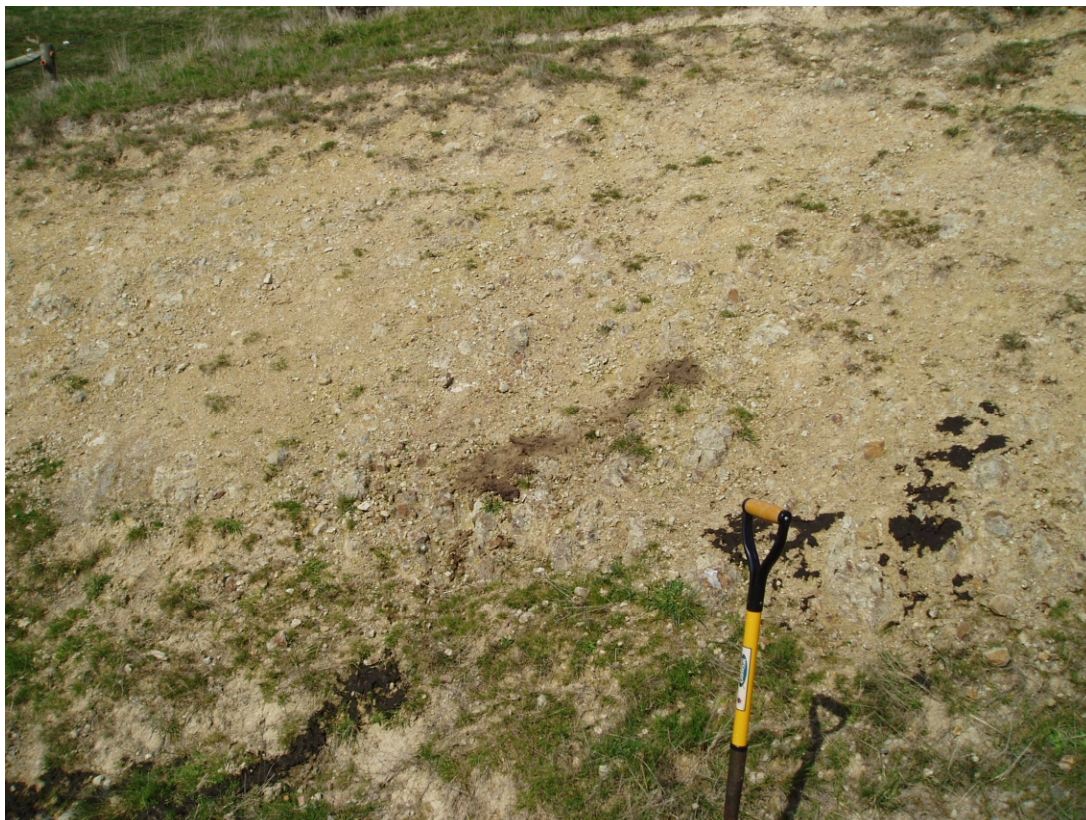
Photograph 1. Rock exposure on track adjacent to proposed Lot 9.

The geological map reproduced as Figure 1 shows that the rocks underlying the site are some of the older units in the Wairarapa area. As observed in exposure (Photograph 1) they are variably weathered, and comprise interbedded sediments ranging from silts to sands, with some cherty units. The rocks have been deformed, and are steeply dipping.

Natural slopes appear to be stable, as are the cut slopes we observed. Excavated slopes along the access road (Photograph 1) and at the house site located in the middle of the proposed subdivision (Photograph 5), are also stable. These slopes have been cut to expose *in situ* rock, and have not required any stabilisation measures.

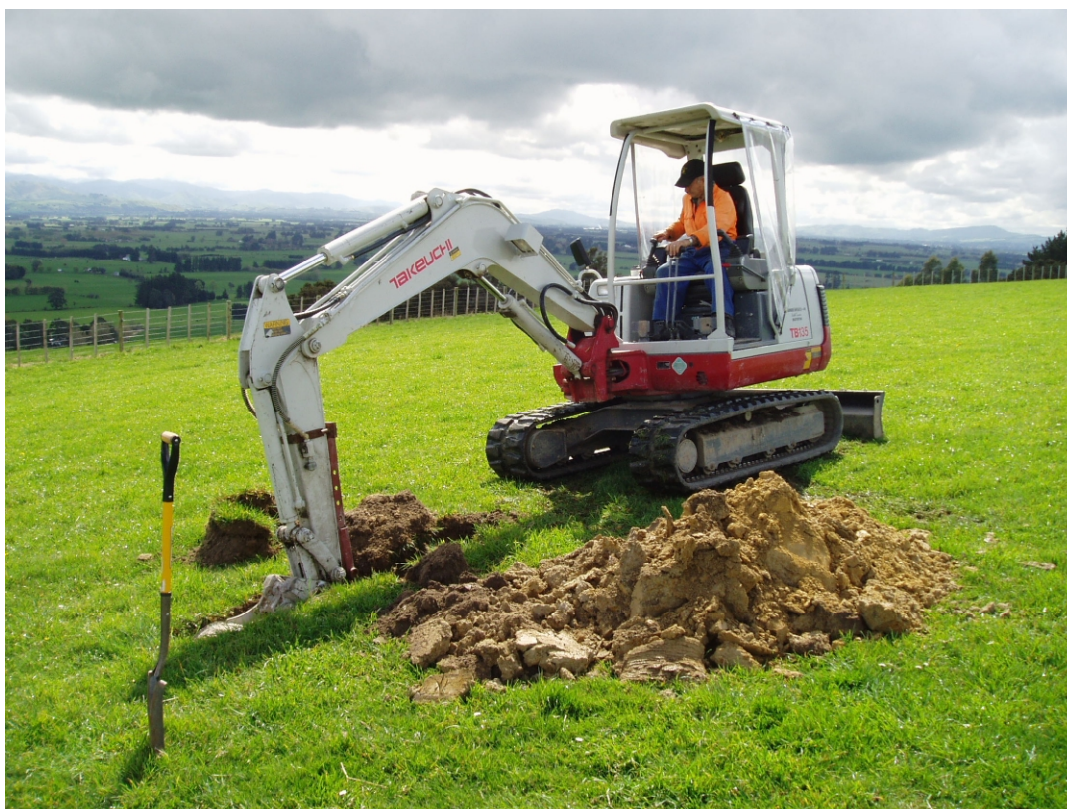
Photograph 2. Excavation of test pit 1

Each test pit was excavated using a mechanical digger (Photograph 2).

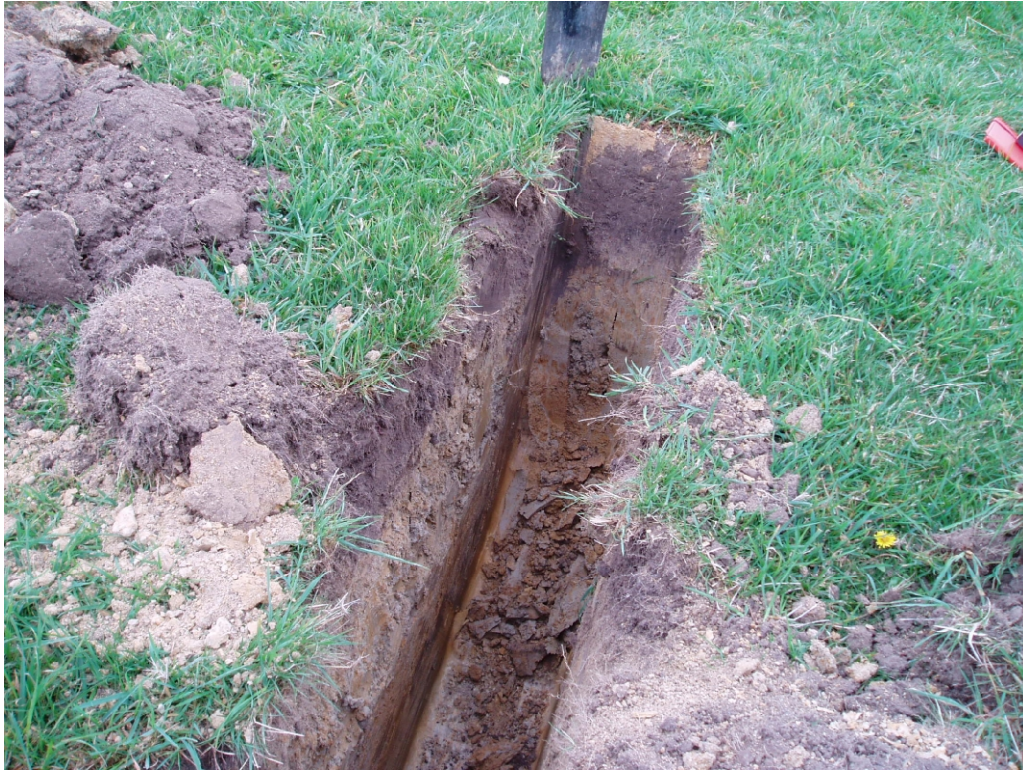
Photograph 3. Test pit 1

At test pit 1:

0 – 0.3m	organic topsoil
0.3m – 0.65m	clay
0.65m – 1.45m	clay, increasing stiffness with depth with occasional clast of weathered siltstone

The excavated test pit is shown on Photograph 3.

The soils exposed by the test pits were undisturbed, with no indication of downslope movement. There was no groundwater encountered in the test pits.

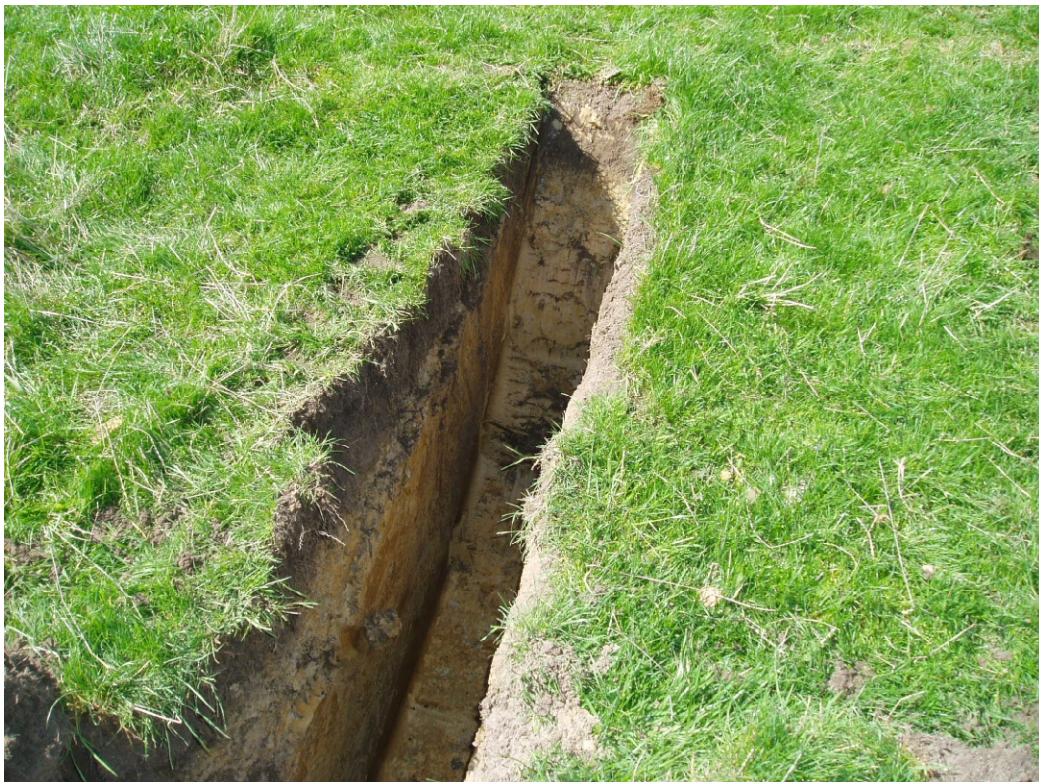
Photograph 4. Test pit 2

At test pit 2:

0 – 0.25m	organic topsoil
0.25 – 1.05m	clay, moist and slightly plastic
1.05m – 1.10m	stiff clay

The excavated test pit is shown on Photograph 4.

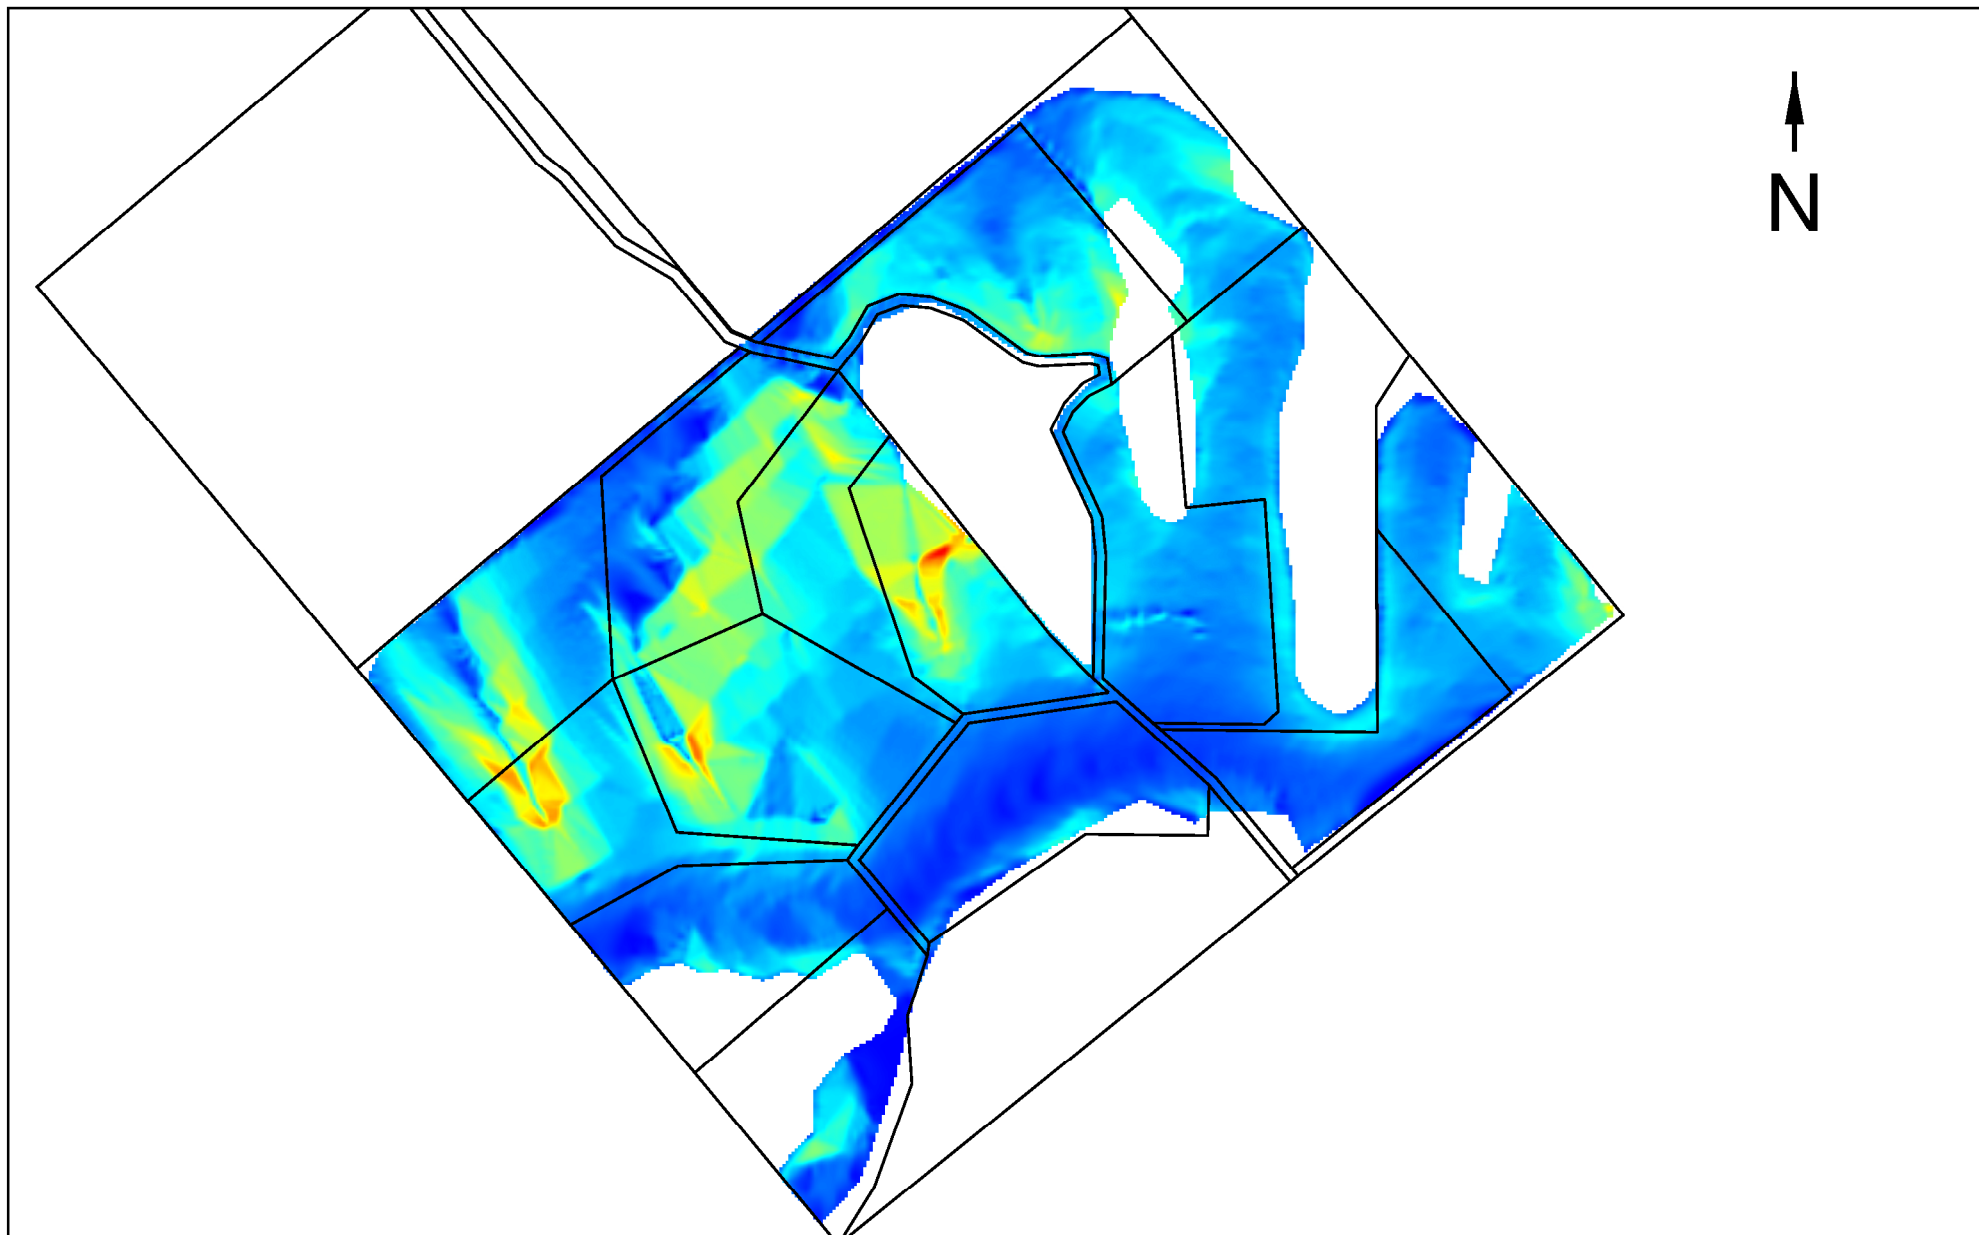
Scaef subdivision - Tiffin Hill  
Slope angle map

Detailed topographic survey information was provided by Tomlinson & Carruthers, and this was used to construct a slope angle map of the proposed subdivision.

The rocks have been exposed to a long period of weathering which has chemically altered the original rock material to predominantly clay minerals. As part of this process, there has been continuous erosion resulting in low to moderate natural slope angles (Figure 2).

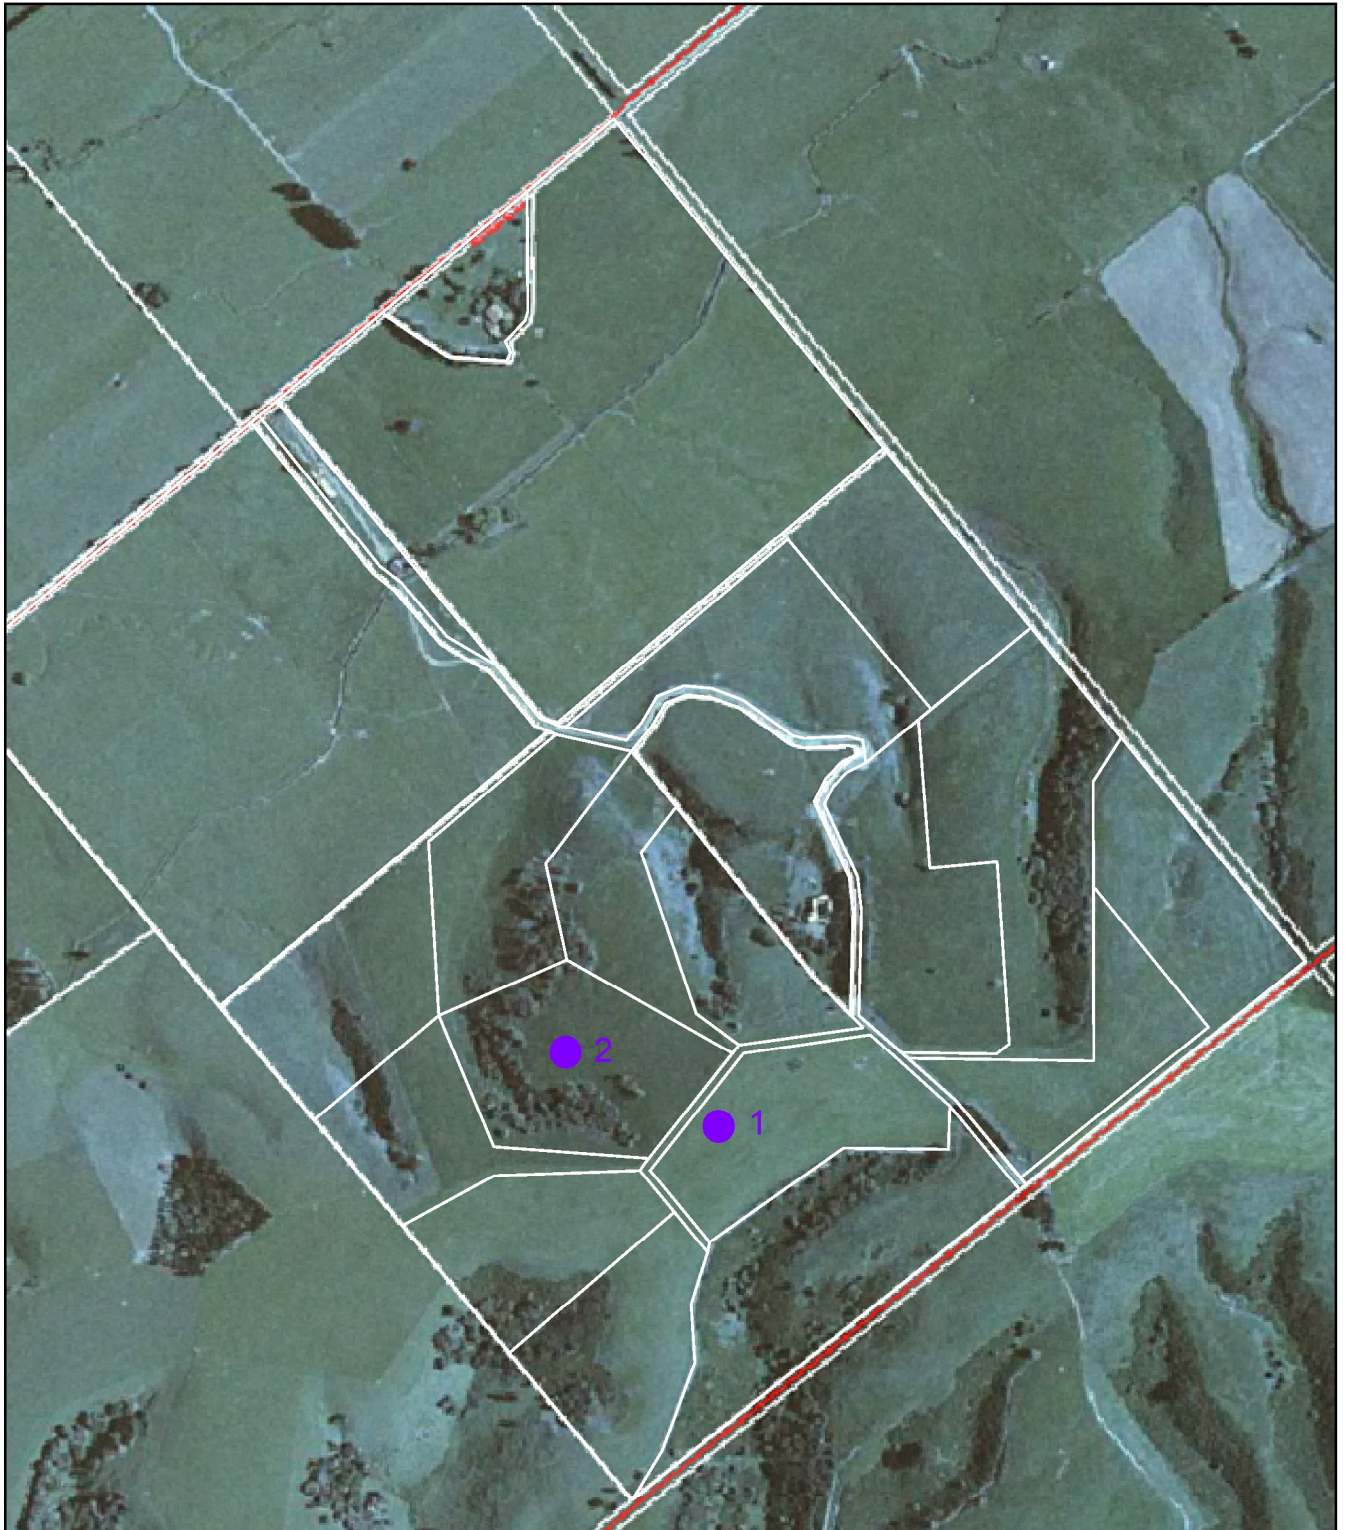
As part of the site inspection carried out on September 20, we supervised the excavation of two test pits. Their location is shown on Figure 3. The objective of the test pits was to determine the soil profile at one of the flatter parts of the subdivision, near the crest of Tiffin

Hill (test pit 1), and to determine the soil profile at one of the proposed house sites on the flank of Tiffin Hill (test pit 2).
