APPENDIX 1 – ECOLOGICAL REPORT ON WAINGAWA WETLAND

Waingawa Structure Plan / Report

Ecological Notes on the Waingawa Wetland

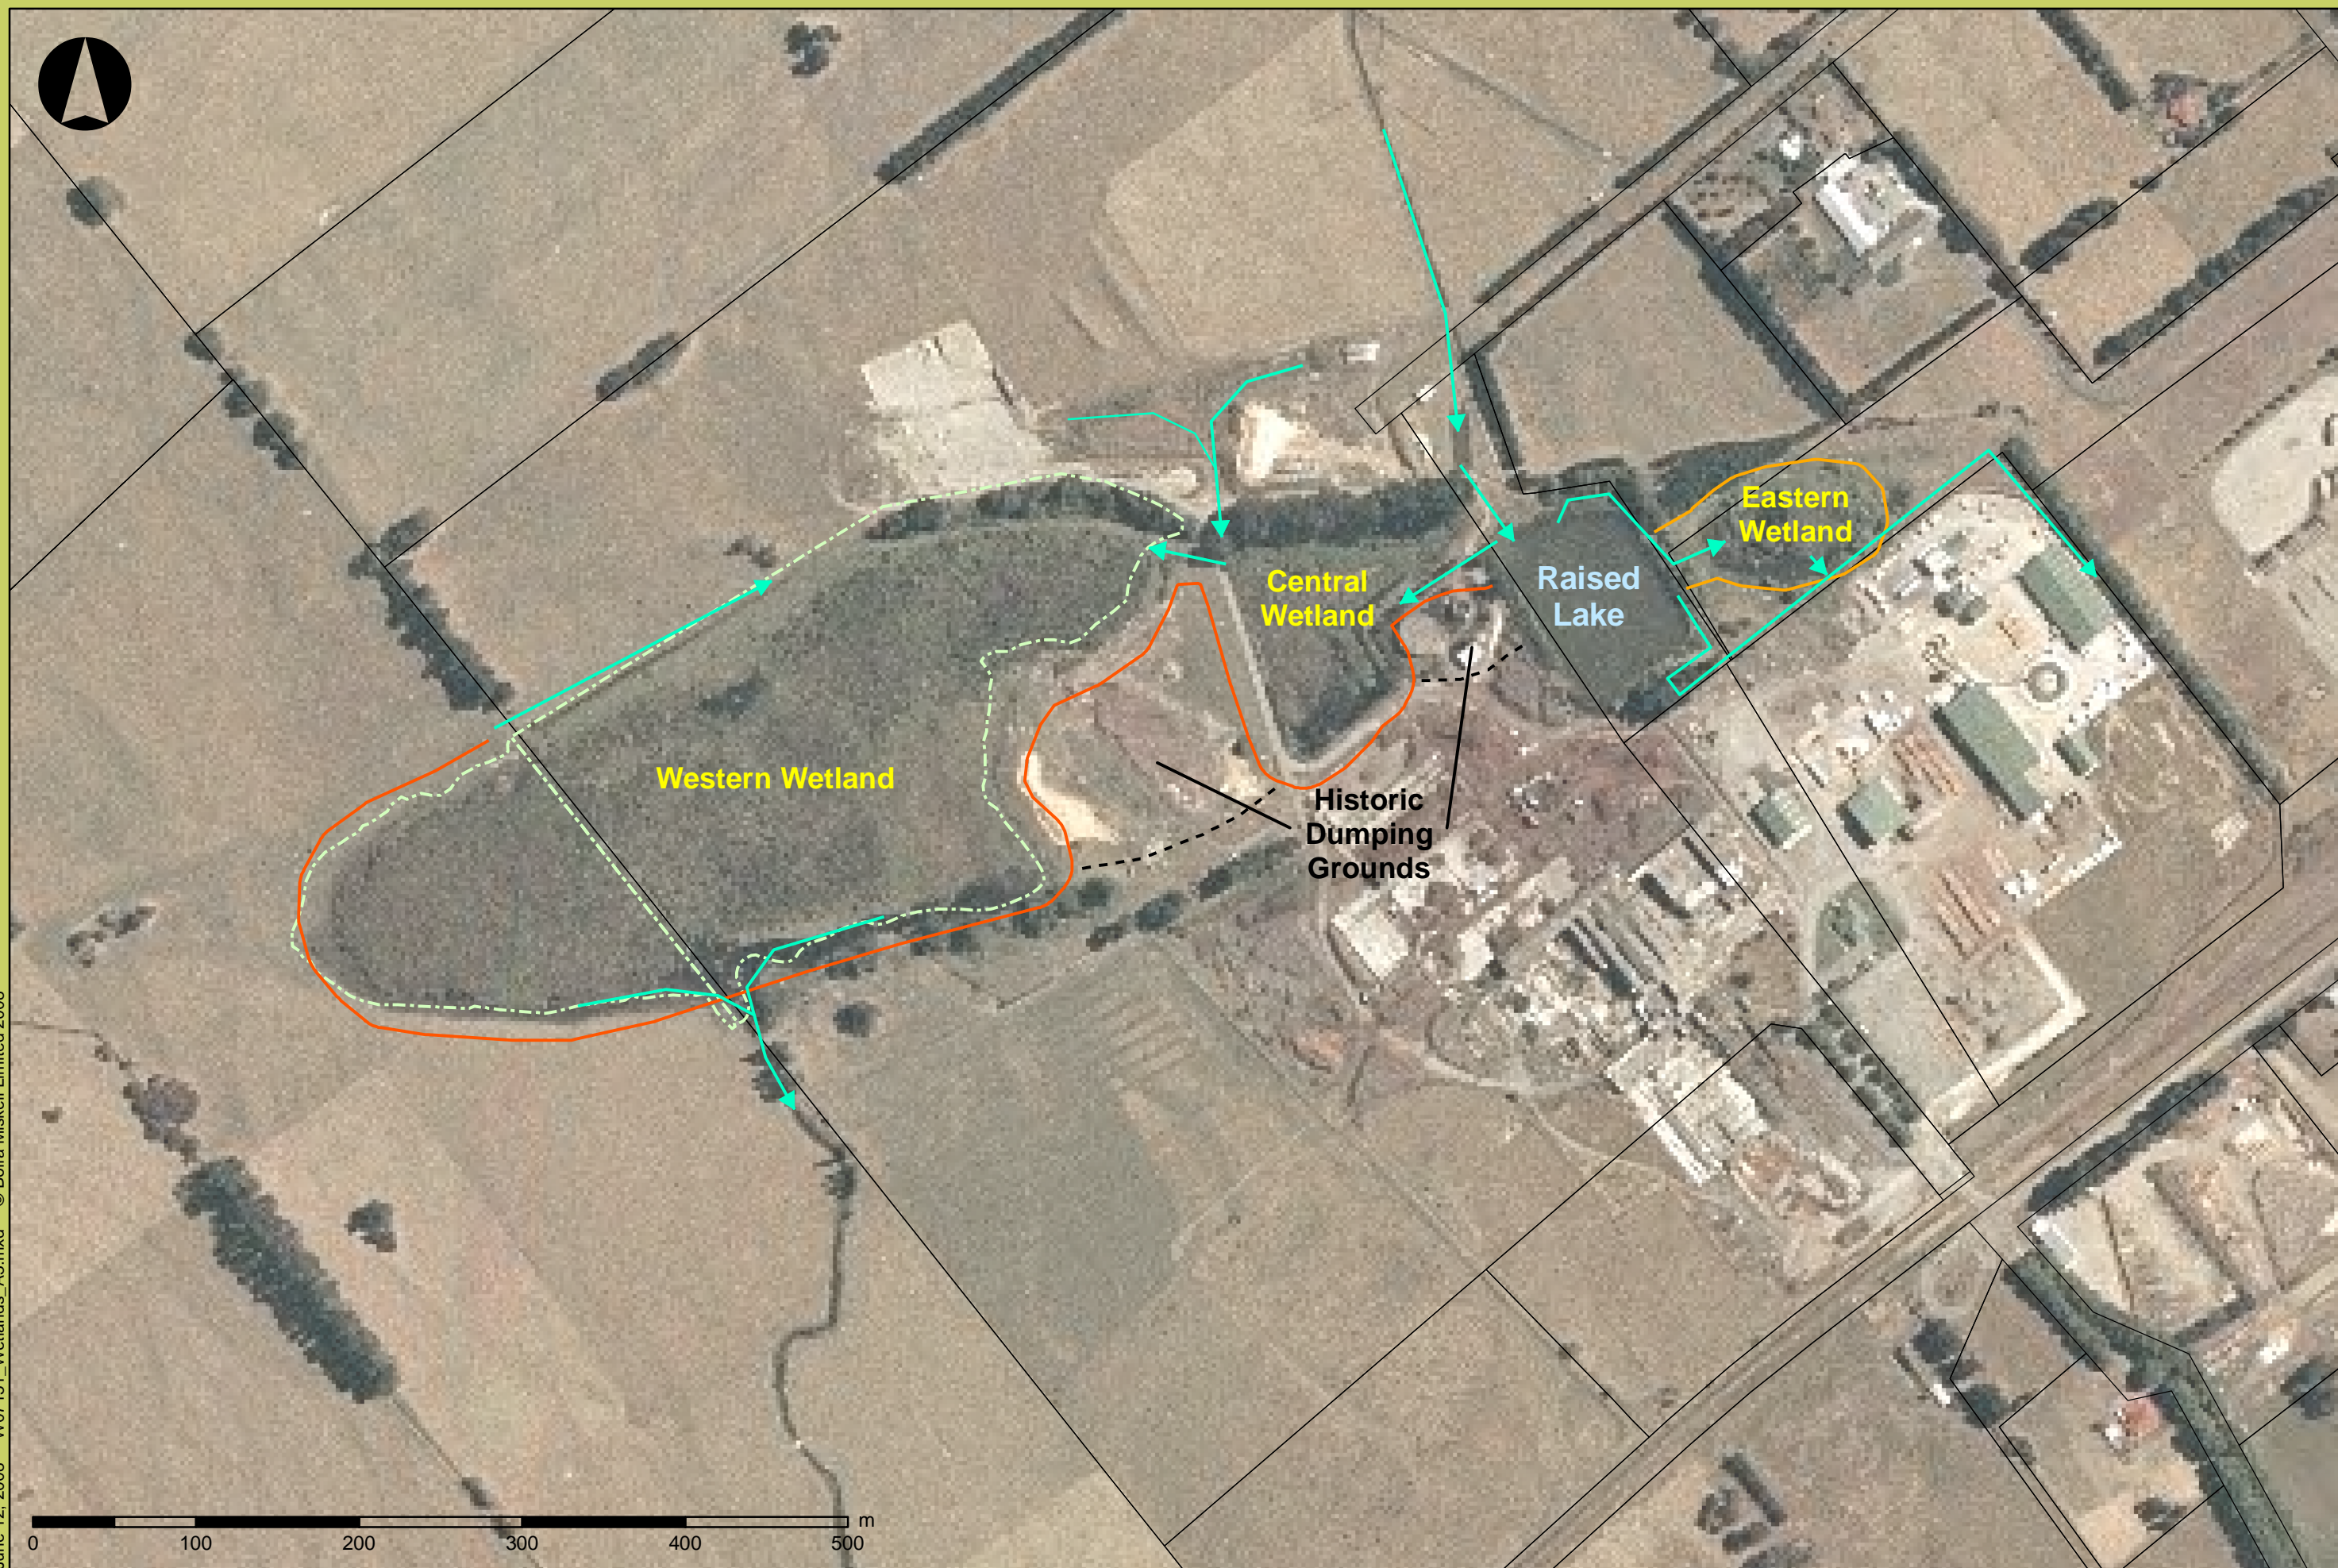
Photo 1. Photo of the raised lake between the Eastern Wetland and the Central Wetland. Raupo surrounding open water.

The eastern wetland comprises two main components: an artificially made small lake (photo 1), and to the east a small area of unmodified wetland. The level of the small lake, which is fed by a stream flowing off the escarpment to the north, is raised above the rest of the wetland by about 2m. Water exits the lake in three different directions: a small amount flows into the adjoining wetland to the east; a small amount flows to the west to enter the central and then western wetlands; and the majority flows into a drain that circumvents the eastern wetland, and drains around the edge of the Kiwi Lumber site, towards Norman Avenue (Figure 1). The water is clear, likely as a result of this regular refushing of the wetland system.

Water levels in the wetlands were observed to be maintained by a water race and raised lake system (photos 1 & 4) and serious thought should be given to ensuring the long-term supply of water to the wetland systems. Any upstream modifications to water inflows, collapses of the raised lake, or other influences could drastically alter these relatively fragile and fresh-water dependent ecosystems.

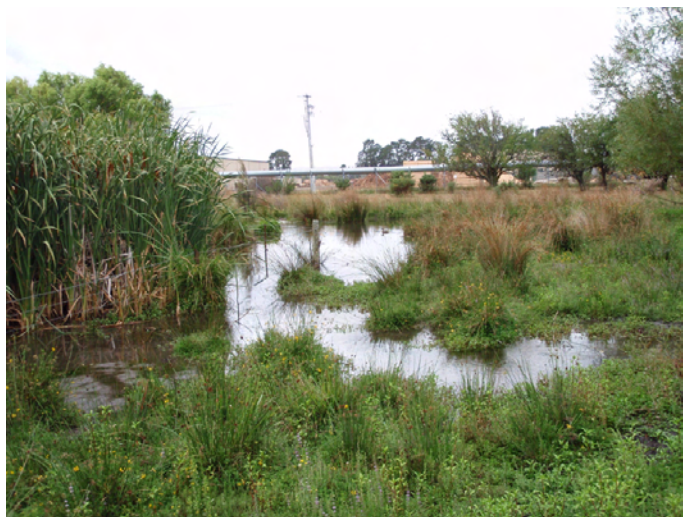
Photo 2. Eastern Wetland illustrating wetland vegetation adjacent to the stream that flows from the raised lake.

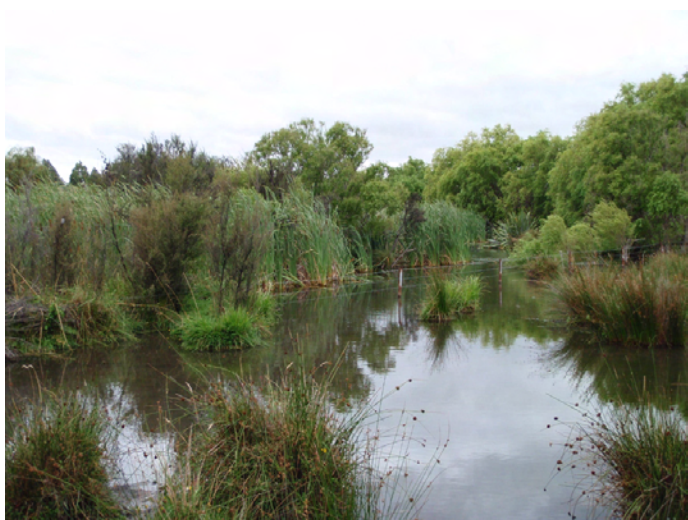
Photo 3. Open water and mixed wetland vegetation of the Eastern Wetland.

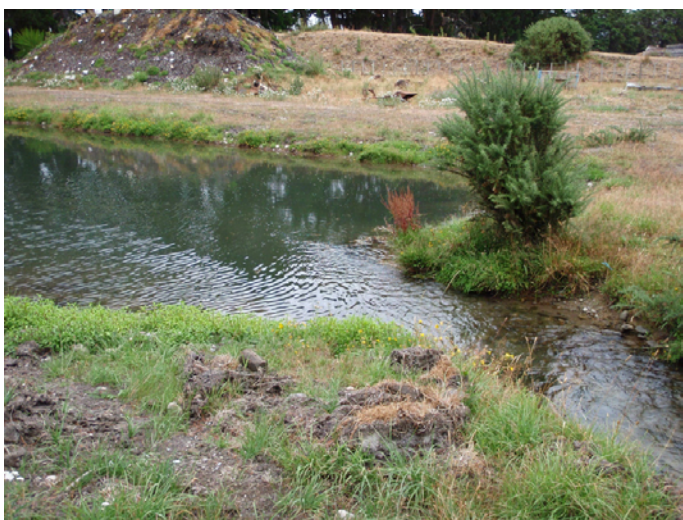
Photo 4. Smaller storage lake located in farmland just above the raised lake.

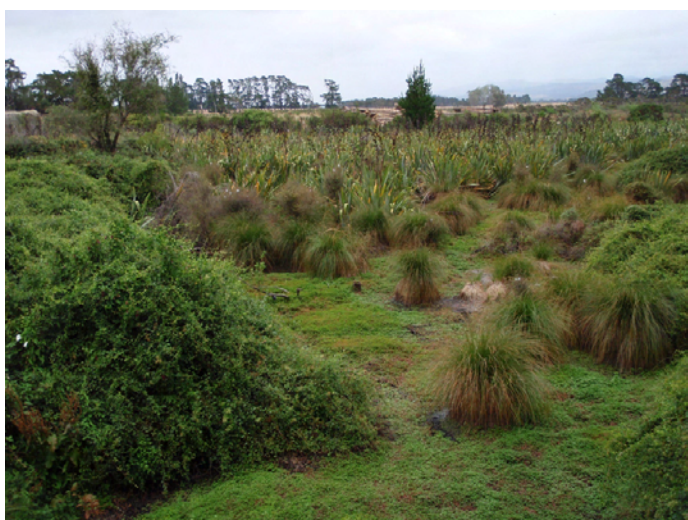
Photo 5. Looking south into the Central Wetland. The Western Wetland can be seen in the distance of this photo.

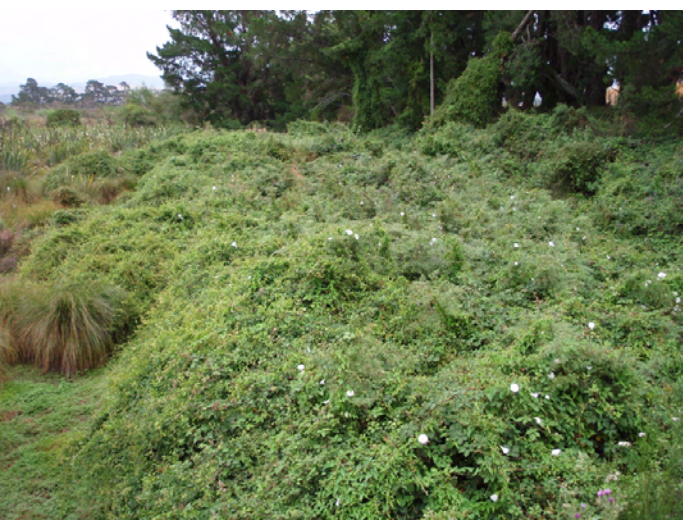
There are a number of weeds present within the wetlands, including *Convolvulus*, Himalayan honeysuckle, blackberry, and gorse and other pasture weeds and grasses. A climbing type of *Muehlenbeckia*, a native, is also present and is smothering a large area of the wetland species below the pines in the area close to the sludge deposit (photo 6).

Photo 6. Convolvulus and Muehlenbeckia within the Central Wetland adjacent to the pine shelterbelt.

This wetland would probably require the biggest expenditure on weed control of invasive weeds, including blackberry, broom and gorse, to prevent their spread. In the long-term, it would be good to remove the surrounding pines and macrocarpa trees in the north as this is affecting the microclimate and natural regeneration under the tree canopy. The area of wetland below the canopy of these trees is also densely affected with weeds, including large smothering populations of the native climber, *Muehlenbeckia*.

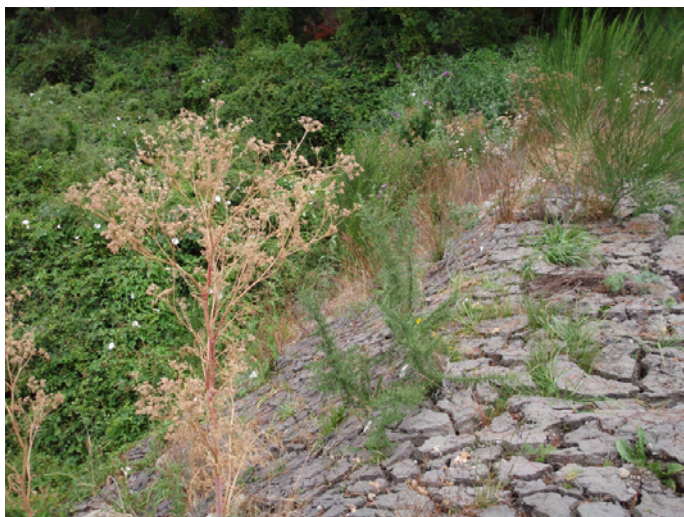
The northeastern edge of the wetland has been historically filled in with sludge and other material (photo 7) and this has destroyed a large area of the original wetland. The ongoing sludge deposition is likely to be contributing to this wetland drying out and it was noticeably drier in the area surrounding the sludge deposition, with a dieback of some wetland plants in this area.

Photo 7. Photograph illustrating the scale of the sludge being dumped into the Central Wetland below the raised lake.

The scale of the fill that has been dumped in the central wetland makes it impracticable to consider excavating it to restore it to its natural extent. However, it is recommended that further dumping of earth or waste cease, and the current edges of the fill be rehabilitated either with plantings or by being grassed over. Dumping of bark chip into the western wetland should also cease and a large proportion of the dumped material should be removed and placed elsewhere or used as mulch in replanting around the wetlands.

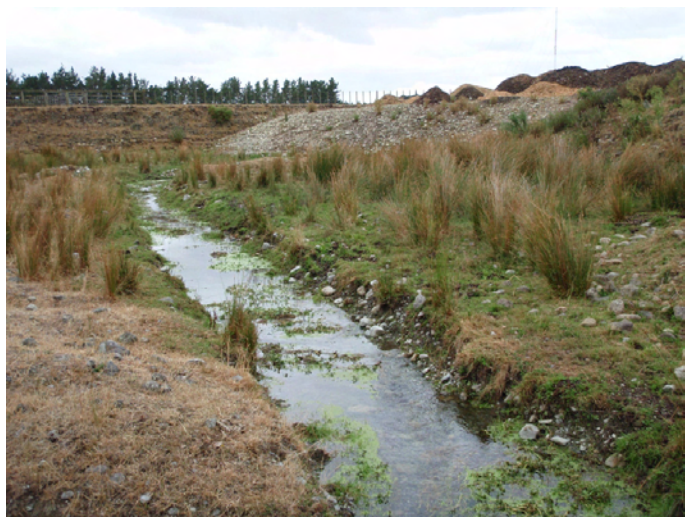
Photo 8 illustrates the small stream that drains into the Central Wetland.

Photo 8. A small stream to the north of the property that exits into the Central Wetland.

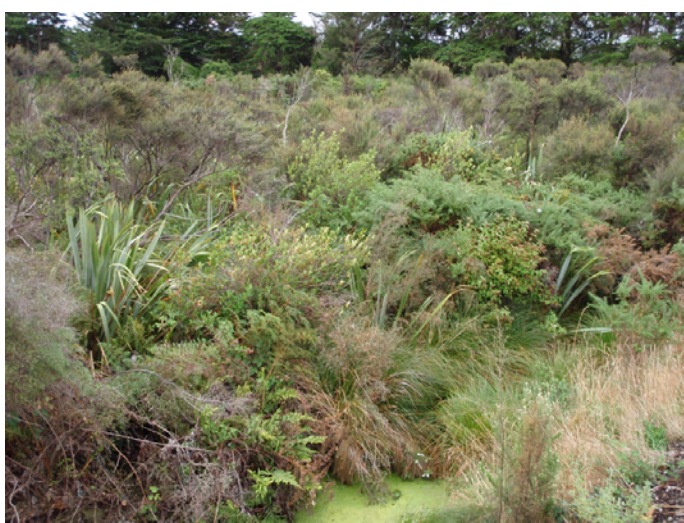
Photo 9. The wetland interior of the Western Wetland illustrating mixed native wetland vegetation and exotic plants.

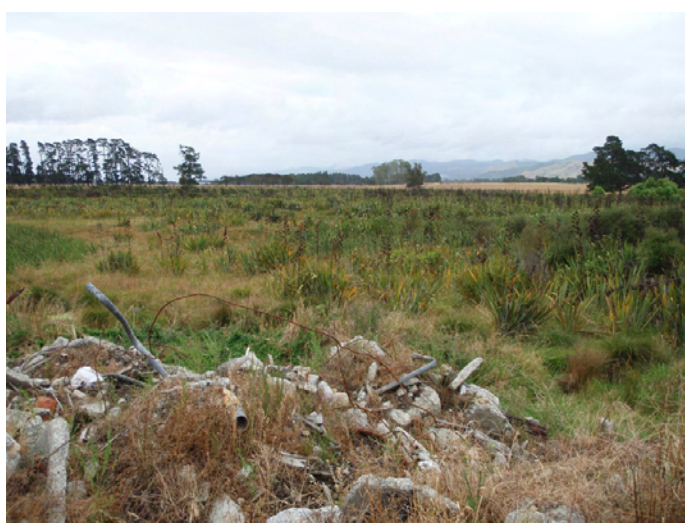
From the aerial photographs, a large component of this western wetland has disappeared as a result of infilling and waste disposal (photos 10 & 12). It is uncertain as to what was included within this waste, but anecdotal evidence suggests it may contain contaminated material associated with the former Waingawa Freezing Works.

Photo 10. Photograph looking south-west across the Western Wetland. Older dumped material in the foreground.

The first priority for this wetland is to cease all dumping of waste bark chips and earth along its edges, and undertake some action to remove the more recent material. The edge could then be contoured and grassed to act as a buffer area. The ground level around this wetland is relatively raised, and the development of a walkway or some form of public access along the southern boundary would create good outlooks over the wetland.

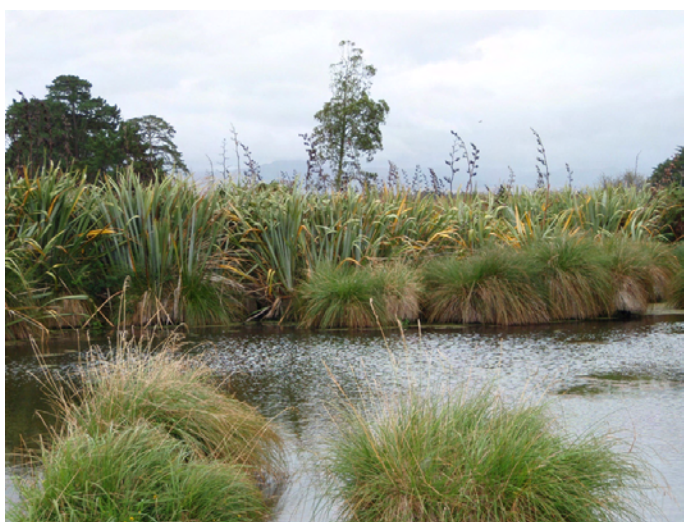
This wetland is perhaps the least modified and the most expansive, with large areas of open water, areas of pure raupo and flax, as well as all the species of the other wetlands. The Protected Natural Area report for the Wairarapa Plains Ecological District notes that the vegetation of the wetlands may have been induced through the clearance of the original forest cover. The presence of a single kahikatea tree indicates that the wetland may have been kahikatea swamp forest (photo 11).

Photo 11. Open water, wetland vegetation and the sole kahikatea in the south-western portion of the Western Wetland.

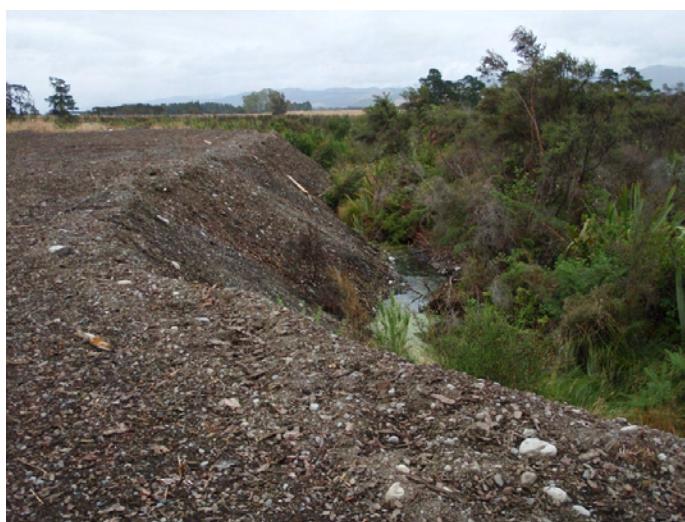
The site visit highlighted a number of ongoing threats to the wetland associated with the timber working and the damage from the historical and recent dumping of a range of matter into the wetland. Two sites are of particular concern, the northeastern end of the central wetland where sludge and landfill is still being placed into the wetland (photo 7) and the more ecologically intact western edge where bark chip and gravel continue to be deposited into the wetland (photo 12).

Photo 12. Bark-chip encroachment into the edge of the Western Wetland. Wetland vegetation to the right and rear of photo.
